LESSONS LEARNED FROM THE 2021 NIPPES, HAITI, POST-EARTHQUAKE ENGINEERING INSPECTION AND DAMAGE ASSESSMENT

Helene TISCHER¹, Kubilay HICYILMAZ² & Pedro NEGRETTE³

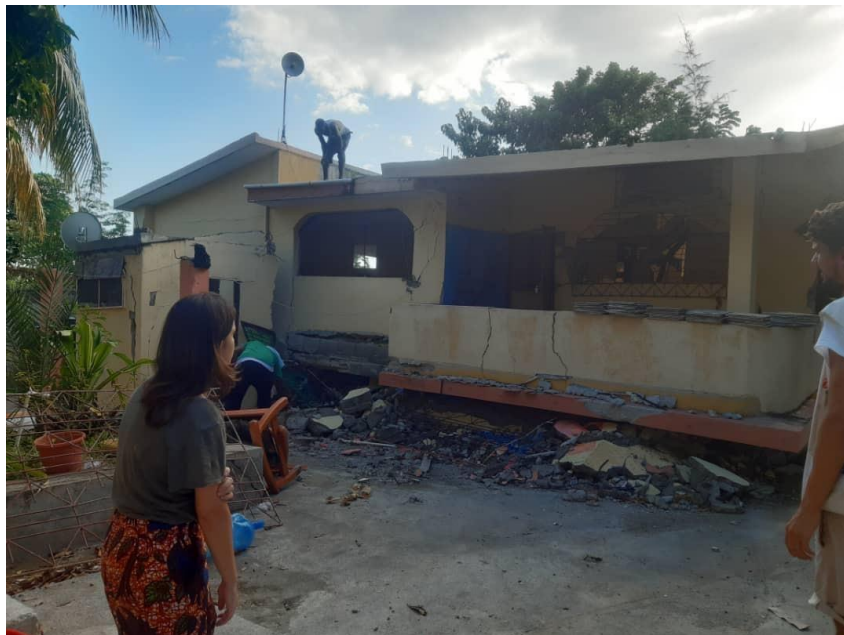
The earthquake had an impact on many of the MSF activities in the affected area. In Port-àPiment, the earthquake severely damaged a public hospital where MSF had provided sexual and reproductive health care for years. Medical services were initially moved outside to tented areas, and MSF then renovated its logistical base to provide space for MSF and hospital staff to treat patients. In addition, the guesthouse suffered a catastrophic failure with the first level completely collapsing, see Figure 2. Given that the earthquake happened on a Saturday morning, staff members were in the building at the time. Luckily and remarkably, there were no fatalities or serious injuries.

Figure 2. Collapsed MSF guesthouse in Port-à-Piment, image courtesy of MSF.

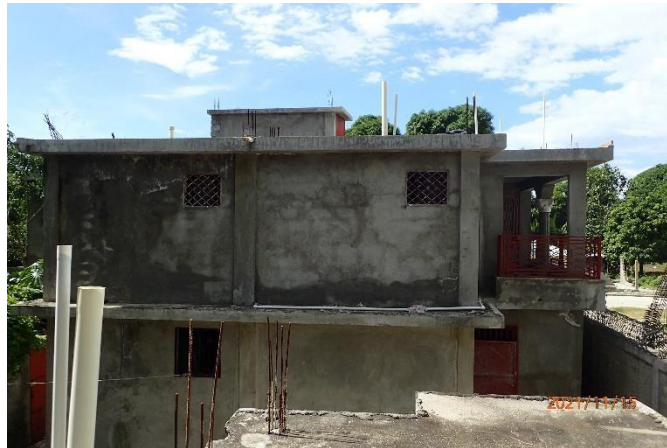
Figure 3. Example of unreinforced hollow block masonry with concrete slabs.

This system has as advantage that it is an economic type of construction that uses readily available local materials. It has demonstrated mixed behaviour during past seismic events, depending on the correct execution of basic guiding principles. Some fundamentals to consider in relationship with this system are:

1. It is important for the unreinforced masonry walls to be confined by columns and beams at all extremities and around all floor and window openings (beams should be present at sill, lintel and roof level). This does not appear to be common practice in Haiti, where columns and beams might be completely missing or only present at some corners of interior wall ends.

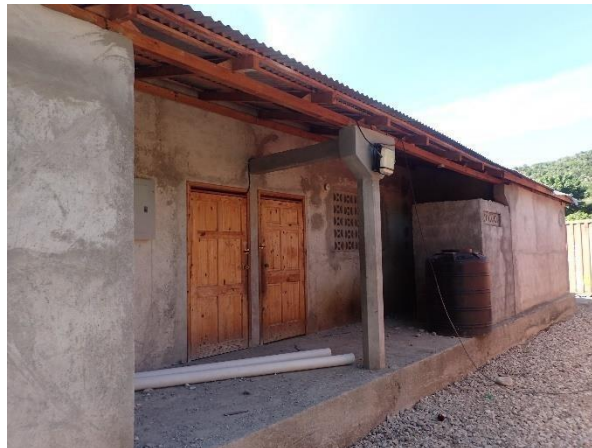
Small, one-storey construction oftentimes uses unreinforced hollow block masonry, typically concrete, with a light steel or wood roof structure covered with corrugated galvanized iron roofing. This type of construction is widely spread along the country as it is cheap and therefore accessible to people with limited resources and was found at MSF facilities for several of the smaller, auxiliary structures. Key points to consider for this type of construction are:

Figure 4. Example of unreinforced hollow block masonry with light roof.

1. Points 1 to 4 of the previous typology are applicable: walls should be confined by columns and beams; the layout needs to be balanced and simple in both principal directions and rebar detailing and spacing needs to be appropriate for seismic regions.
2. Masonry walls should be interlocked at the corners to prevent the walls to overturn in the event of an earthquake.
3. The light roof should be properly attached to the masonry structure. Care should be given to create a positive (tension) connection between the walls and the diaphragm to provide out of plane restraint to the walls.
