PERFORMANCE OF REINFORCED CONCRETE BUILDINGS IN THE 2023 KAHRAMANMARAS EARTHQUAKES

Burak SAHIN¹ & Ahmed ELGHAZOULI²

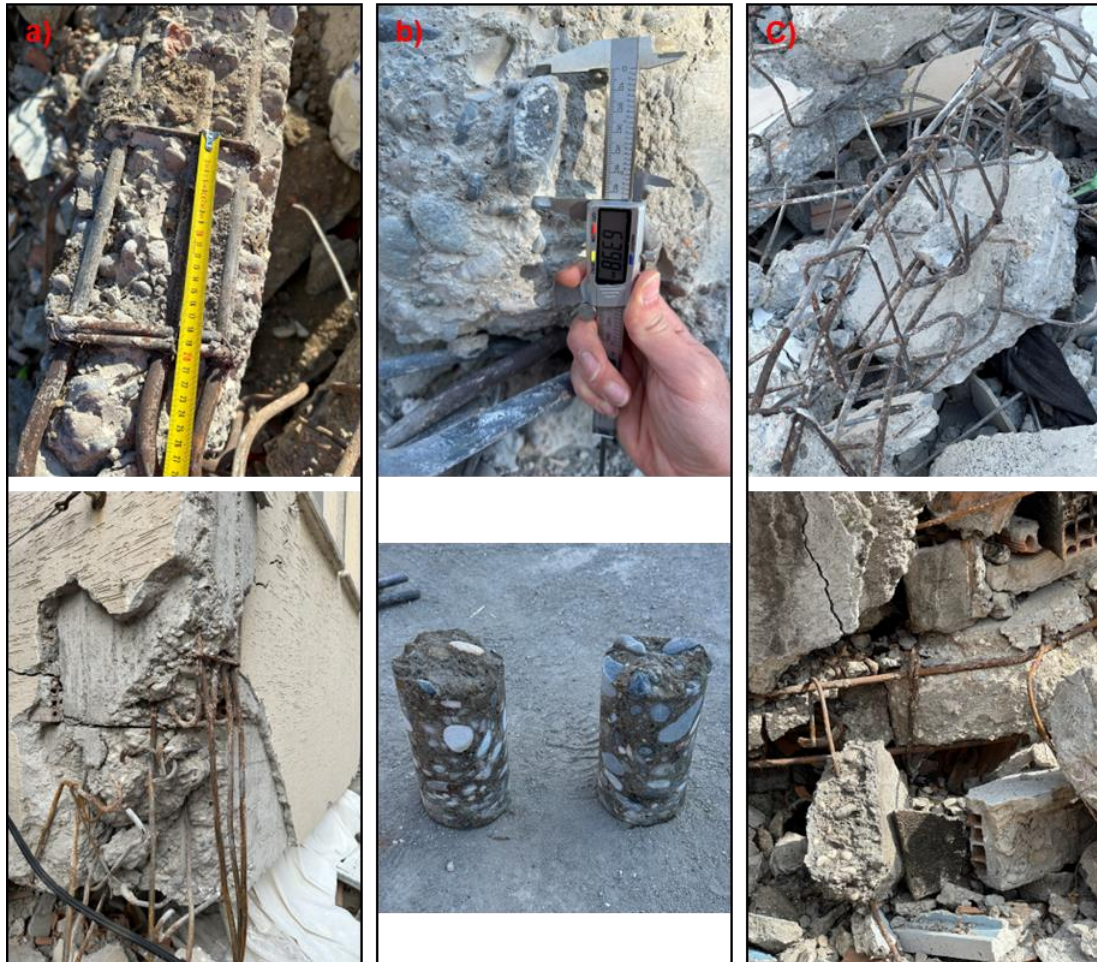
Common shortcomings in frame-type buildings constructed prior to 2000 included the inadequate stiffness and strength within lateral resisting systems, utilization of smooth-surfaced reinforcement bars, poor detailing of steel reinforcement especially within the beam-column connection regions,

excessive corrosion of steel, and low concrete material strength, leading to severe damage and many collapses. Figure 5 shows examples of common issues related to steel reinforcement and concrete material. As indicated in the figures, the amount of steel reinforcement is relatively low and rebars are excessively corroded, whilst concrete is segregated and contains coarse smooth-surfaced aggregates with around 7-8 cm diameter. These reduce significantly the bond capacity between the rebars and concrete material as shown in Figure 5.

Figure 5. Typical material and detailing deficiencies in pre-2000 buildings; a) Smooth-surfaced rebars with 90° hooks at the ends of stirrups and deficient detailing; b) Anomalous size and shape of aggregates; c) Excessive corrosion and poor reinforcement detailing.

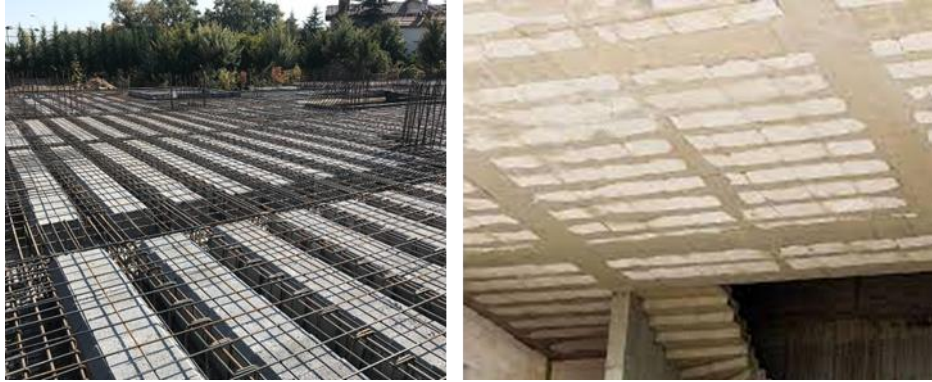
Another key issue is the common use of ribbed floor slabs due to architectural preferences by the end of 2010s. In this type of floor, beams are hidden within the slab, resulting in a flat ceiling without any obstructions. An example of its application is shown in Figure 6. The thickness of this type of slab varies between 30-40 cm. Therefore, in order to hide the beams within the slab, the designer needs to use shallower beams which significantly decrease the bending capacity. Depending on the filling material between the ribs, the weight of the slab can increase notably, leading to heavier buildings hence higher seismic forces. Whilst ribbed slabs can provide rigid diaphragm behaviour in the direction parallel to the ribs, it is quite weak in the direction perpendicular to the ribs and, in most cases, a relatively rigid diaphragm is hard to obtain. Due to their poor seismic performance, their adoption is restricted in the most recent Turkish seismic code (TBDY, 2018), with respect to the type of building, seismic zone, and use of shear walls. As observed in the building inventory, the vast majority of pancake-type failures as illustrated in Figure 7, has been observed in buildings incorporating ribbed floor slabs,

Figure 6. Examples of ribbed floor slabs construction.

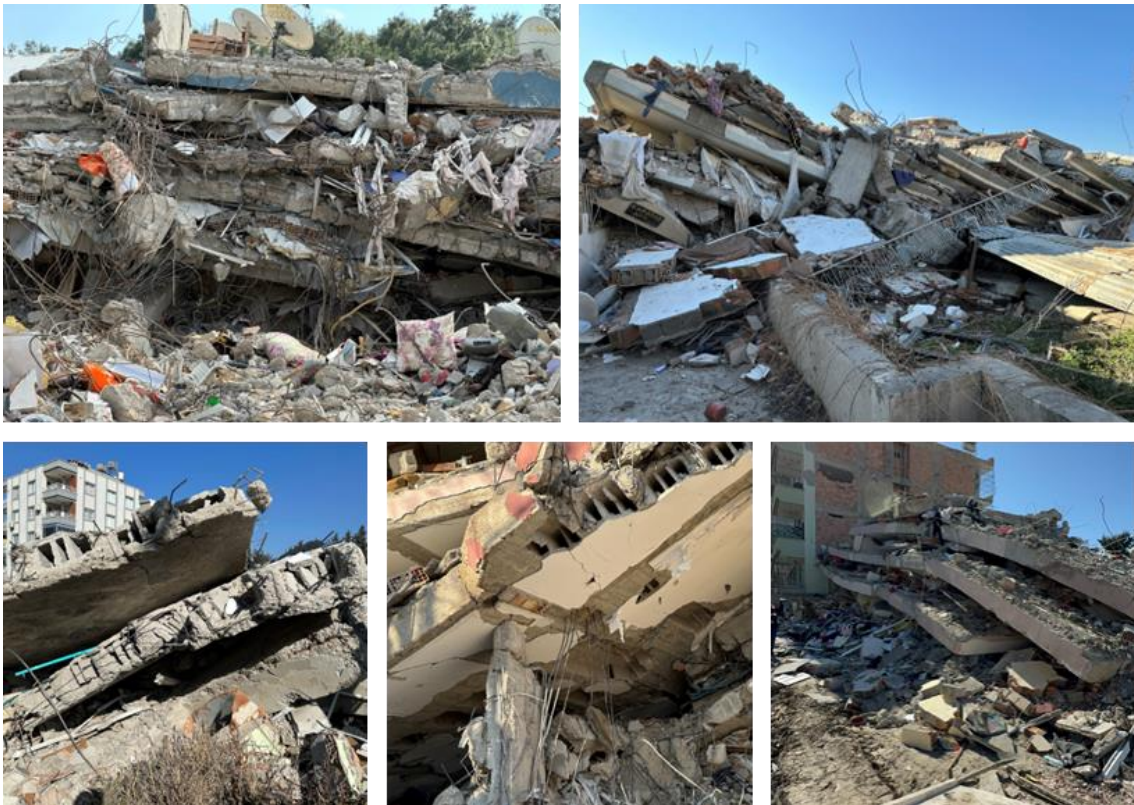
Figure 7. Failures of buildings with ribbed slab.

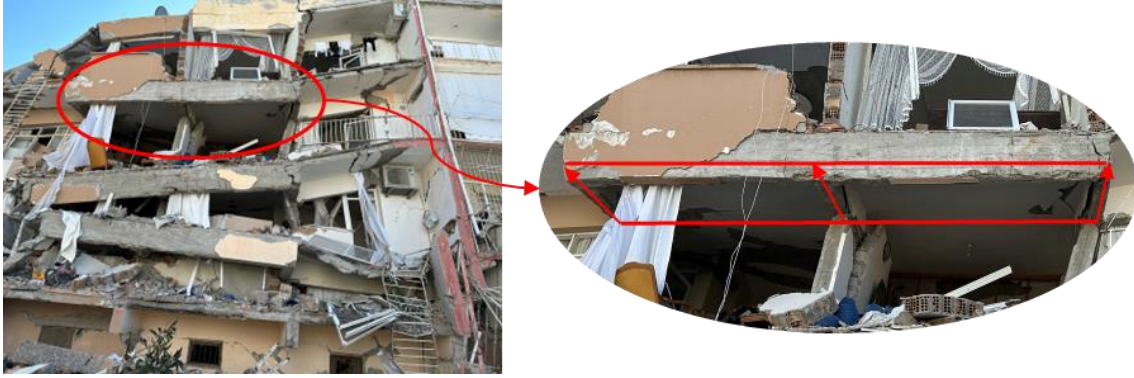
Examples of deficient design were also commonly observed. A typical example is the inadequacy or even absence of a proper lateral resisting frame system. Mostly due to architectural purposes or restrictions by construction law, mushroom-type buildings are quite common in Turkey, despite it being undesirable in such high seismic risk regions. The current construction law does not allow the use of the entire site to construct the building, as in many countries. However, it allows the floor areas to be increased for storeys above the ground floor. As for the architectural side, designers usually move beams connecting external columns to the façade to avoid having drop beams visible within the flat floor, as illustrated in Figure 8. Proper frame action is therefore not obtained on the storeys above the ground floor. This also remained a common issue in buildings constructed after 2000. Due to the severity of this problem, this type of construction is under consideration for prohibition in the near future by building codes in Turkey.

Figure 8. Example of inadequate lateral resisting frame system.

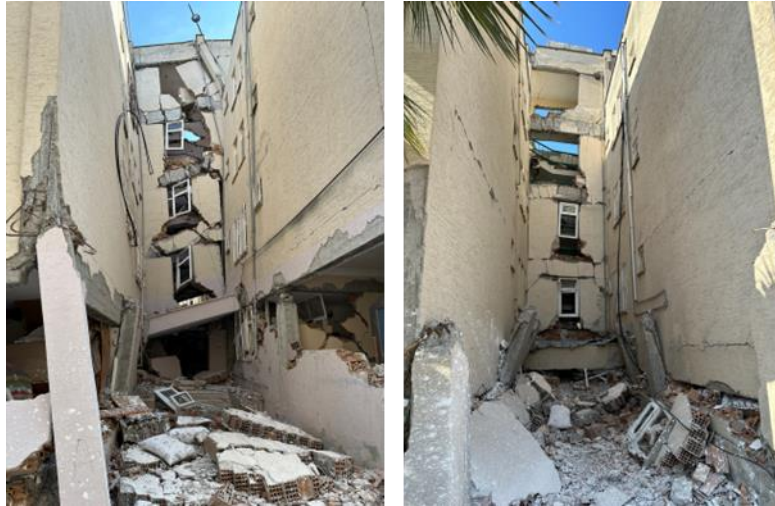
Figure 9. Failures of two identical buildings.

Another type of repeatedly observed failure is shown in Figure 9, which shows typical failures of two identical buildings. The poor design of the bridge between the blocks is clear. There is no seismic expansion joint, and the bridge is connected to the blocks via a fixed support. When considering the short length of the beam members, the shear failure as seen in the figure is evident. Also, the quality of connection design and reinforcement detailing is quite low, all leading to a soft storey failure.

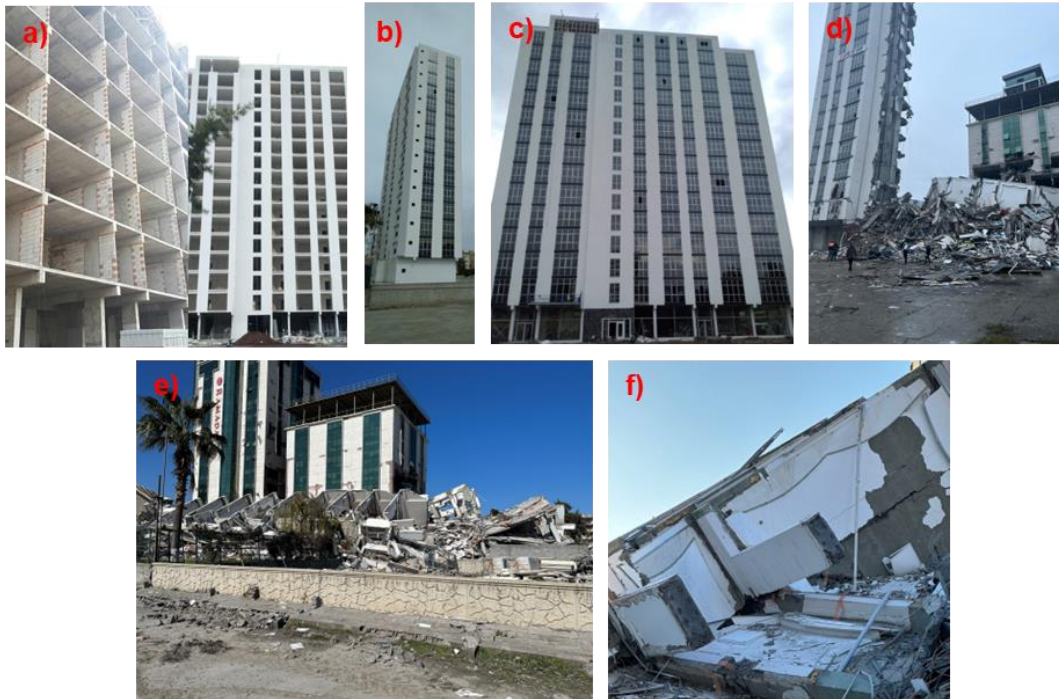
Figure 10 shows an example of a recently constructed 17-storey RC building in Iskenderun, including basement, ground floor, and roof. The figure includes photos during construction, when completed, after the 1st earthquake and the full collapse after the 2nd event. As clearly shown in the figure, the lateral resisting system is inadequate. Whilst the frame system seems to be formed in one direction, there are no beams connecting the columns in the other direction. This type of multi-storey buildings both in plan and elevation requires the use of proper lateral resisting systems in orthogonal directions, with adequate stiffness, strength and ductility. However, in this case, the stiff elements are formed around the lift shaft. These shear walls prevented half of the structure in plan from collapse during the first earthquake.

Figure 10. Example of post-2000 building collapses; a), b), and c) Before the earthquakes; d) After first earthquake; e) and f) After second earthquake.

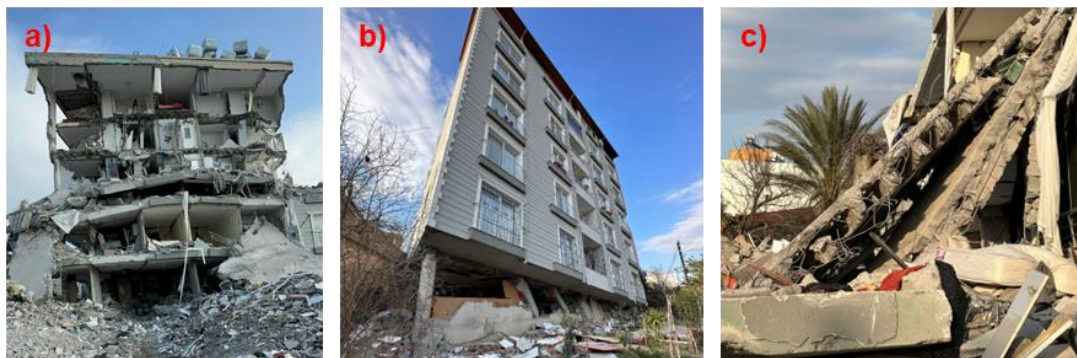
Figure 11. Illustration of collapses in post- 2000 buildings; a) Front view; b) Back view with softstorey mechanism; c) View of ribbed floor slab.

Another example failure of a building constructed after 2000, is shown in Figure 11. The building was designed as an RC framed building with ribbed floor slabs. The ground floor was used for commercial purposes as a showroom with little or no infill walls which, unless coupled with adequate design and detailing, often leads to soft storey failures as illustrated in the figure. The floor area of the storeys above the ground floor is also increased, and ribbed floor slabs with poor seismic performance, as discussed earlier, were utilised in the building. All these factors, individually or in combination, led to the collapse of many buildings in the affected areas.
