TRANSITION FROM SHELTER TO HOME

Abstract: This paper focuses on the process of transition from temporary accommodation to permanent housing after disasters. The magnitude of some disasters results in a shortage of housing that cannot be covered by the regular building industry and durable accommodation cannot be achieved in the short-term. Sheltering during this period can be provided through different approaches, such as transitional shelter. When this approach is used, families remain in a condition of temporariness and uncertainty until they reach a permanent solution. Because the process of building durable accommodation can take years, transitional shelters are changed by families over time in order to meet their needs. Cases of transitional accommodation provided by the Government and TECHO NGO in Chile and Peru are analysed to illustrate how families modify their houses. Cases studied show similar characteristics in the way families expand and modify their shelters focusing on creating a 'home' even in a temporary situation.

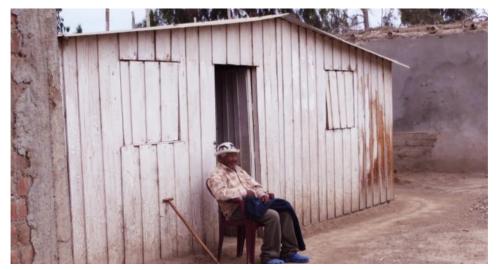
Figure 1. Non-modified transitional house in Peru after 5 years of use provided by TECHO. (Wagemann)

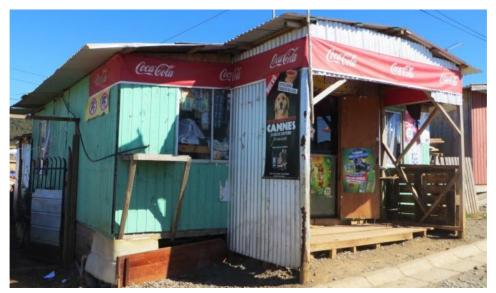
Figure 2. Example of a modified transitional house in Dichato, Chile, 2012. (Wagemann)
