## SHARED KNOWLEDGE ON EARTHQUAKE RECOVERY AND RECONSTRUCTION: THE NEPAL EEFIT 2022 RETURN MISSION

**Abstract:** *On the 25th April 2015 a magnitude 7.8Mw struck Nepal, followed by two strong aftershocks on the 26th April and 12th May (6.7Mw and 7.3Mw, respectively). Over 9000 people were killed, 22,000 injured with over 500,000 homes either damaged or destroyed, resulting in economic losses of over US\$7 Billion. A key component of understanding the resilience of Nepal to future events is understanding whether Nepal has “Built back better”, developed resilient communities for the future and has in place recovery strategies and preparedness plans. In May 2022 the Earthquake Engineering Field Investigation Team (EEFIT) returned to Nepal. Through a range of approaches including stakeholder workshops, stakeholder questionnaires, social media studies, ludic activities, remote sensing, landslide reconnaissance and revisiting field locations from the 2015 EEFIT mission, the team aimed to investigate the earthquake recovery and reconstruction and evaluate whether Nepal had built back better. The assessment of the societal aspects identified that pre-2015 there was a lack of preparedness

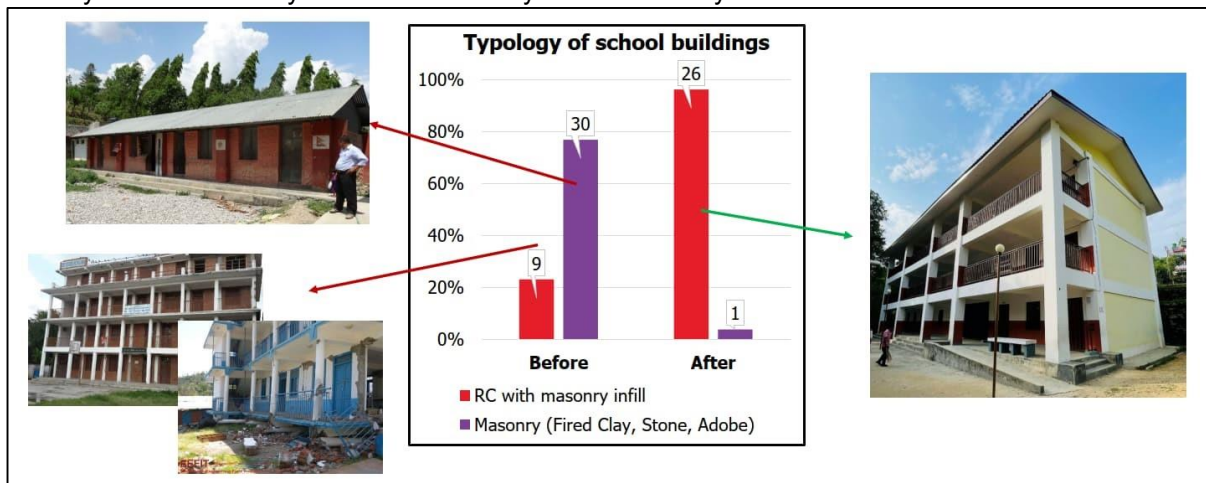
While most of the pre-earthquake school buildings belonged to masonry typology, almost all of the schools surveyed had newly constructed multi-storey RC buildings (Figure 7) with masonry infill which appeared to be constructed in accordance with the latest National Building Code of Nepal. Construction quality observed on school sites was equivalent to international best practice with supervisors and resident engineers providing quality control. However, by applying checklists such as FEMA P-154 rapid visual screening, some existing/added seismic vulnerabilities were identified in few cases such as:

Figure 7. Distribution of the pre- and post-earthquake typologies of school buildings along with typical photographs.

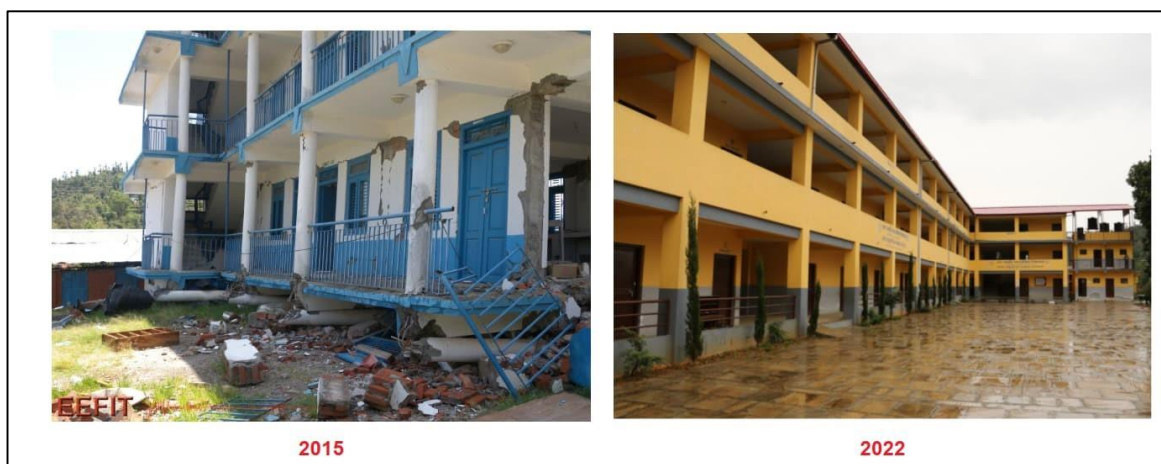
Build Back Better has clearly been achieved for schools (Figure 8) with a significant improvement in the seismic design and detailing, construction quality, number of classrooms and water, sanitation and hygiene (WASH) facilities. However, it is noted that the education sector was a priority and is likely to have received the most support.

*Figure 8. Poorly designed RC building damaged by the 2015 earthquake sequence (left) and a newly constructed RC building in the same school compound.*

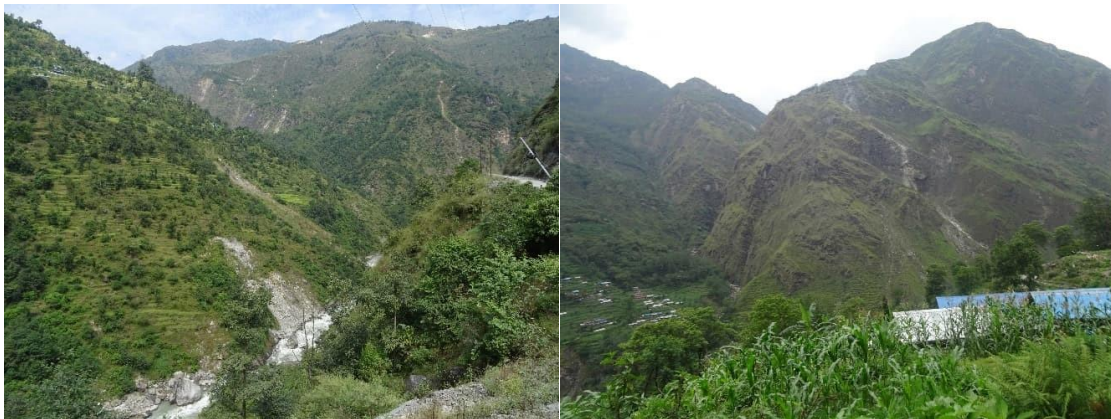
Initial field observations were undertaken in 2016, 2018, 2019 (Whitworth *et al* 2020; Jones *et al* 2021a), with subsequent field visits undertaken in 2022 to evaluate the resilience and recovery of the infrastructure to these landslide events. The subsequent field visits identified that the landscape appeared to be recovering from the earthquake induced landslides (Figure 9), with little evidence of continued reactivation, confirming the findings of Jones *et al* (2021). Although aspects of the road infrastructure was repaired in 2018, this had been further damaged in 2022 (Figure 10). Hydropower infrastructure impacted by the earthquake, has now been repaired. Although the border and highway had reopened to a low volume of traffic and along the corridor there appeared an increase in economic activity, the critical infrastructure continues to be impacted by landslides, with previous mitigation measures having minimal impact.

*Figure 9. Example of revegetated earthquake-induced landslides following the Nepal 2015 earthquake, mapped in 2019 and 2022.*

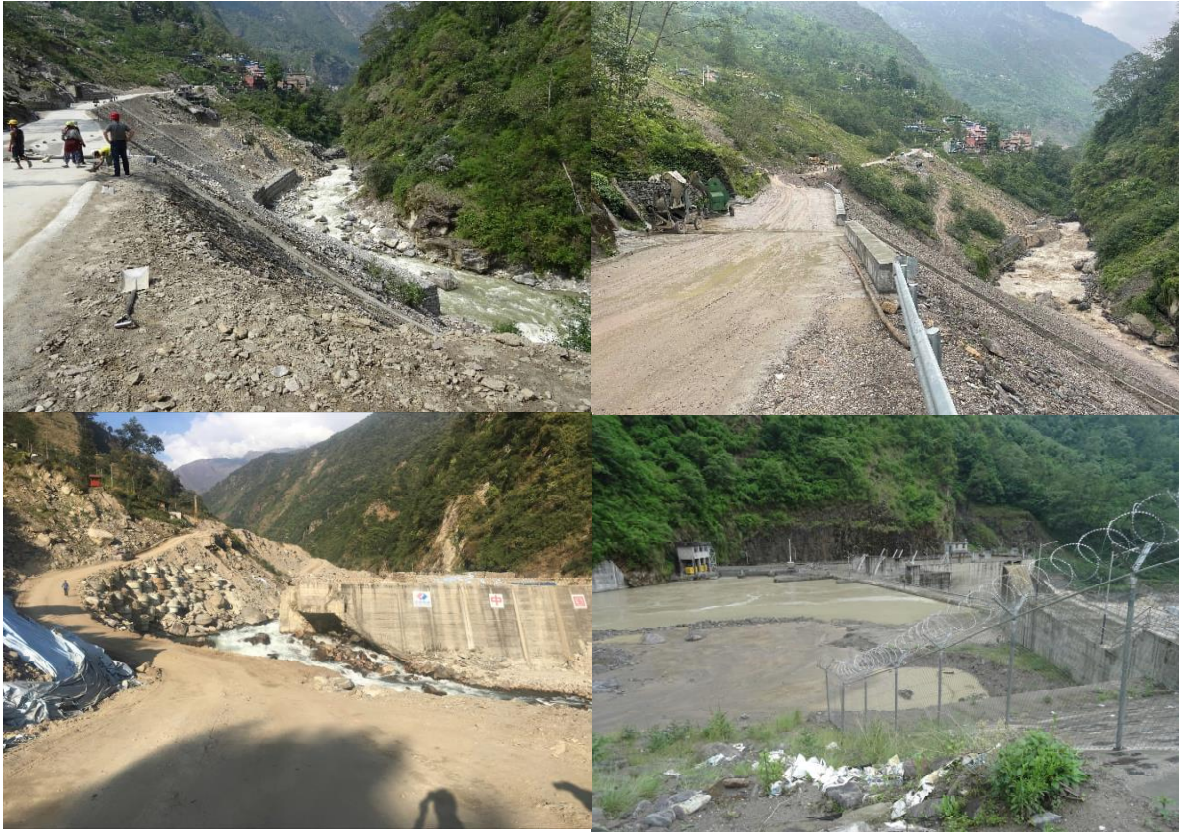
Figure 10. The recovery of road and hydropower infrastructure along the Ariniko highway, left 2017, right 2022.
