## SEISMIC DESIGN OF LOW-COST AND SUSTAINABLE CANE, TIMBER AND MORTAR HOUSING FOR EL SALVADOR

Arup in conjunction with an El Salvadoran NGO named REDES have developed a form of low-cost, seismically-resistant and sustainable housing that uses cane, timber and cement mortar. This paper presents an evaluation of existing low-cost housing in El Salvador, an assessment of the seismic risk within the country, and a description of the new design proposed and its seismic performance. The seismic design approach is discussed, and findings from full-scale cyclic in-plane testing of a wall panel, out-of-plane shake-table testing of a section of wall and bi-directional shake-table testing of a complete room are presented. The testing indicates that this form of technology has some ductility, exceeds the design capacity both in-plane and meets Life Safety performance for the El Salvadoran code design level, as well as the criteria based on the latest seismic hazard studies. The paper proposes that this form of housing can be used in highly seismic areas.

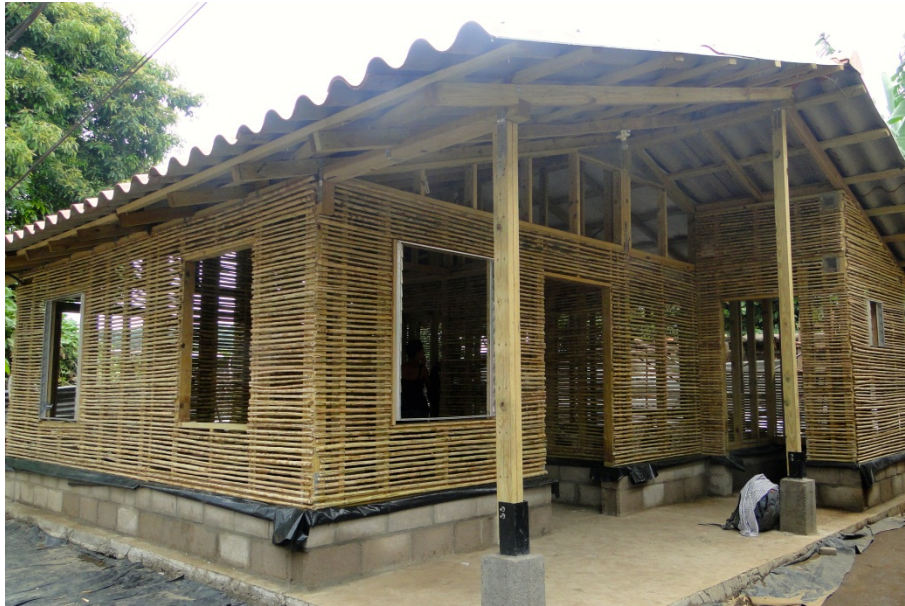
Figure 1. Prototype cane and mortar house under construction (El Salvador Project, 2012)

After conducting research into existing low-cost housing in the Latin American region, in particular using bamboo structurally (Kaminski, 2013), the team developed a solution which takes the vernacular *bahareque* design and “engineers” it by essentially: treating the timber and wall matrix against insect attack, replacing the mud render with a more durable and stronger cement mortar and engineering the connection details (Figures 1-4).

Two prototype houses were successfully constructed in El Salvador in 2012 and another one in 2014, and have allowed the house design and construction method to be optimised (El Salvador Project 2012, 2012; El Salvador Project 2014, 2014). They were evaluated again in 2013 and the families living there were very happy with them, with no reported structural problems.

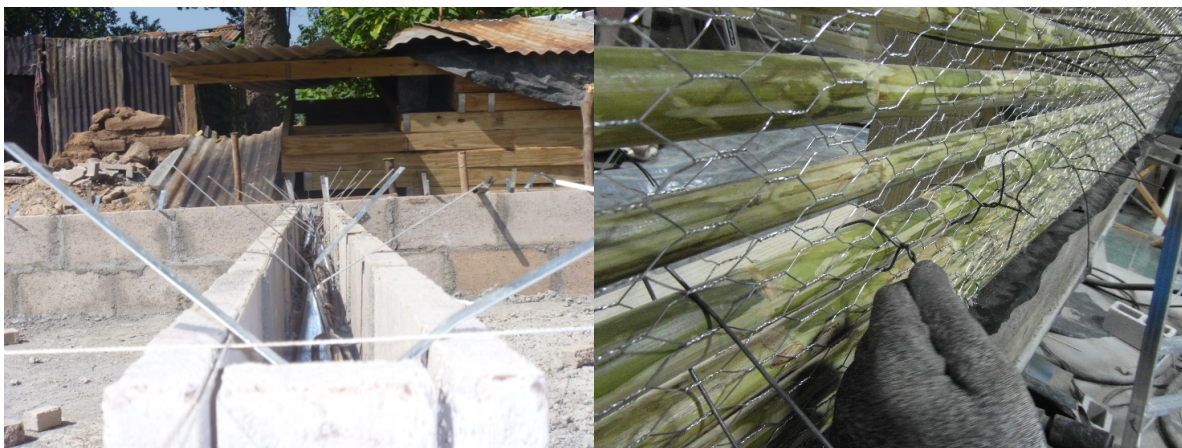
Figure 2 (L). Blockwork to timber connection detail (El Salvador Project, 2014); Figure 3 (R). Cane, mesh and wire wall detail before application of cement mortar (Kaminski, 2014)

The design that has been developed is a single-storey four roomed building, approximately 6m x 6m, with two bedrooms, one living room and one kitchen. The foundations of the house are a thin reinforced concrete slab sitting on reinforced concrete ground beams under the walls. The walls sit on two courses of hollow reinforced blockwork, protecting the frame above from water and insect attack. The wall and roof structural frame sits on the blockwork and consists of a simple 2”x4” structurally graded and pressure-treated pine frame, nailed together with capacity-designed steel straps at key locations to resist wind and seismic loads. The walls are wrapped in a thin galvanised chicken mesh on both sides, and *vara de castilla* (also known as *caña brava* – a local type of cane approximately 25mm in diameter and up to 6m long (Chan, 2014)) is nailed to the frame. The *vara de castilla* is sourced from local farmers and is treated on site against insects with boron. Cement mortar is then

plastered on both sides of the walls to form the 60mm thick shear walls. The lower halves of the walls are painted with waterproof paint to protect against driving rain. The roof consists of lightweight cement fibreboard sheeting screwed down onto the timber purlins and rafters. The design life of the house is 30 years with minimal maintenance (painting and keeping the walls dry). In comparison with reinforced blockwork, which is widely seen and used as the current low-cost housing of choice by the government, NGOs and communities themselves, this new form of housing uses up to 40% less cement and steel. It is also overall lighter and hence easier to transport to more rural areas.

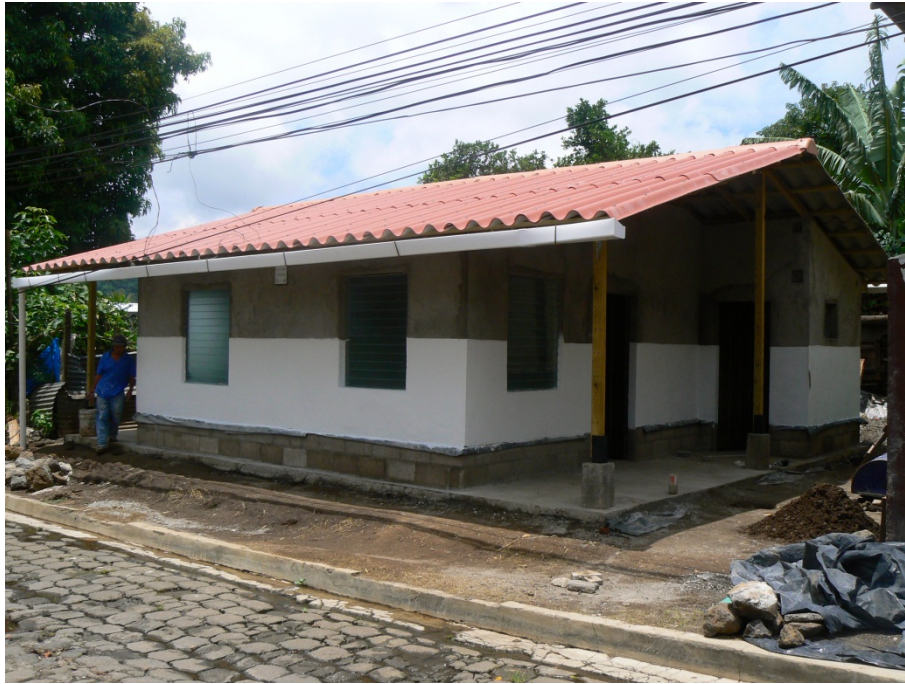
Figure 4. Prototype cane and mortar house, completed in 2012 (El Salvador Project, 2012)

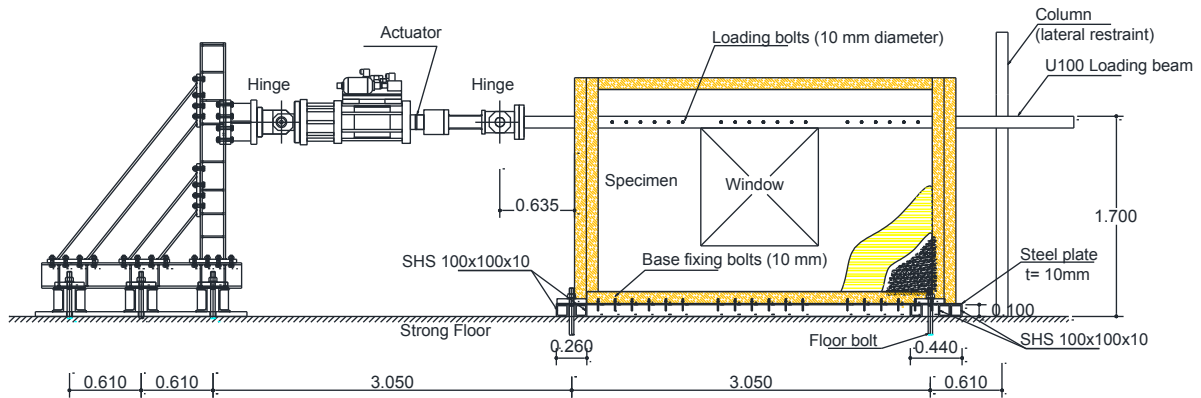
Figure 5. Elevation of in-plane test specimen (Málaga-Chuquitaype et al., 2014)

The 2013 study tested at full scale six different wall panels each with different geometrical and material characteristics. The wall panels tested were 3m long, 1.85m high, and with 1m return walls at each end, with most tests incorporating a 1m x 1m window (Figure 5). The panel dimensions matched the typical wall size to be used in the final design. The panel was

bolted down to the lab floor along its length and on the wall returns, replicating the fixings in the final design. Steel chicken mesh was fixed to only one side of the panel. The load was applied via a loading beam situated with multiple bolts along its length (in order to distribute the load and avoid local crushing) and situated at  $\frac{1}{4}$  of the way down the height of the panel, in order to better replicate the actual centre of application of net horizontal load (and reduce the risk of a flexural failure occurring).

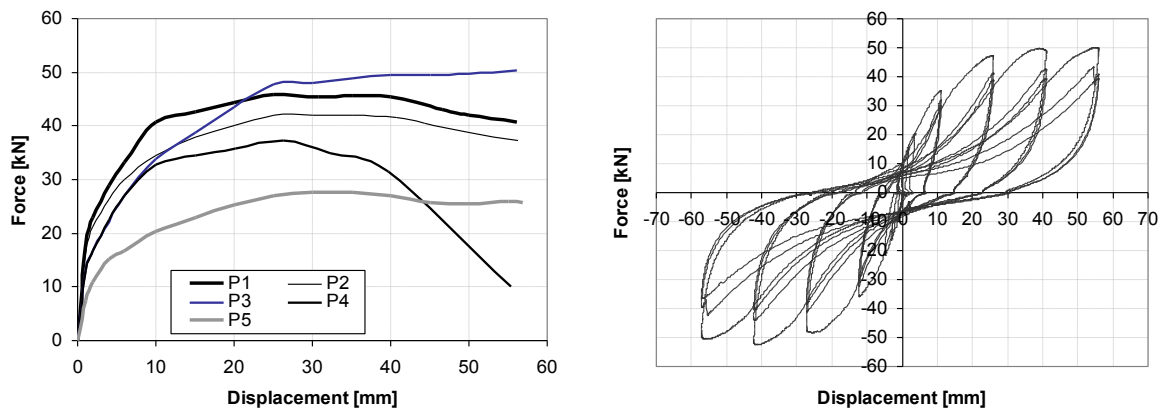
Figures 6 (L). Envelopes of the force-displacement hysteresis for different panel types (Málaga-Chuquitaype et al., 2014); Figure 7 (R). The force-displacement hysteresis for one of the panels (Málaga-Chuquitaype et al., 2014)

The panels were each tested under cyclic displacement control based on the EN12512 protocol (CEN, 2005). The results of the tests demonstrated that for drifts under 1% the panels showed relatively stable hysteresis, with reasonably good levels of energy dissipation (Figures 6 and 7), and the level of damage seen was considered acceptable. Initial cracking occurred at 15-20kN (drifts of  $\sim 0.1\%$ ), with the ultimate load achieving 37-50kN (drifts of  $\sim 1.5\%$ ). Initial failure manifested itself by a combination of diagonal shear cracking and spalling of the side of the panel without mortar (Figure 8). The steel mesh was found to stabilise the diagonal compression strut in the remaining mortar, and the ultimate failure mode was local buckling and crushing of this mortar.

The test panels achieved the design horizontal load before the initial cracking load was reached. The design for the strength of the panels assumed no ductility reduction factor (i.e. to Eurocode 8 ductility factor  $\mu = 1$ , or to IBC response modification factor  $R = 1$ ). In addition, the relatively stable hysteresis demonstrates that these forms of panels have some ductility, in the region of an R value of 2 to 3 for drifts under 1% and assuming the elastic capacity is approximately 15-20kN. Lastly, the variables used in the tests, such as the mortar strength,

were all lower bounds suggesting that the system will have some additional overstrength, and that high levels of quality control of the mortar are not essential. The testing suggests that the panels more than meet the design capacity assumed, and that in future a response modification factor greater than 1 could be used.

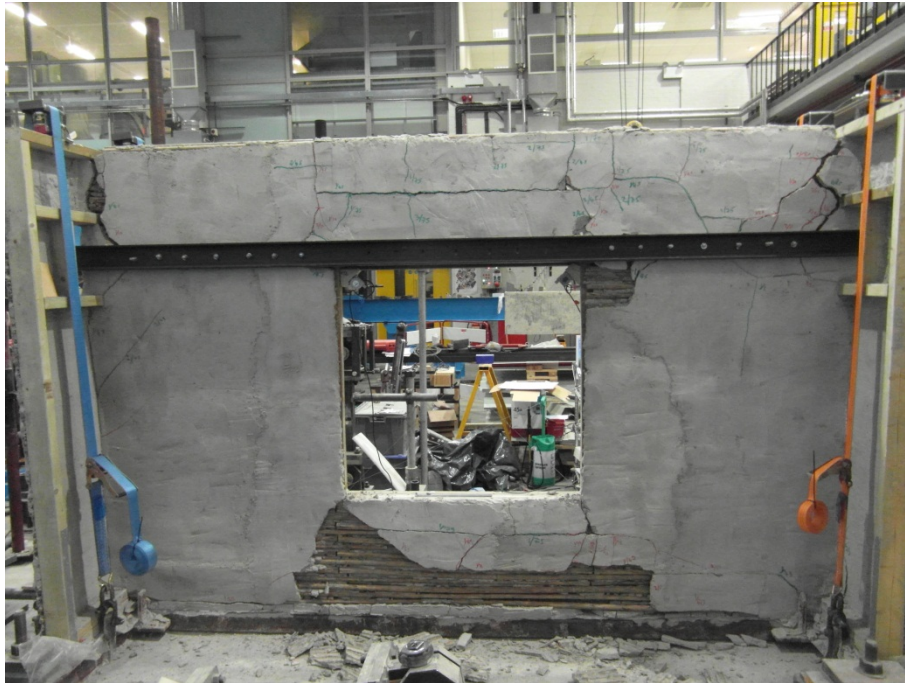
Figure 8. In-plane testing of wall panel at Imperial College London, 2013. Image shows typical damage state at failure, using singly-sided chicken mesh on reverse side only (Kaminski, 2015)

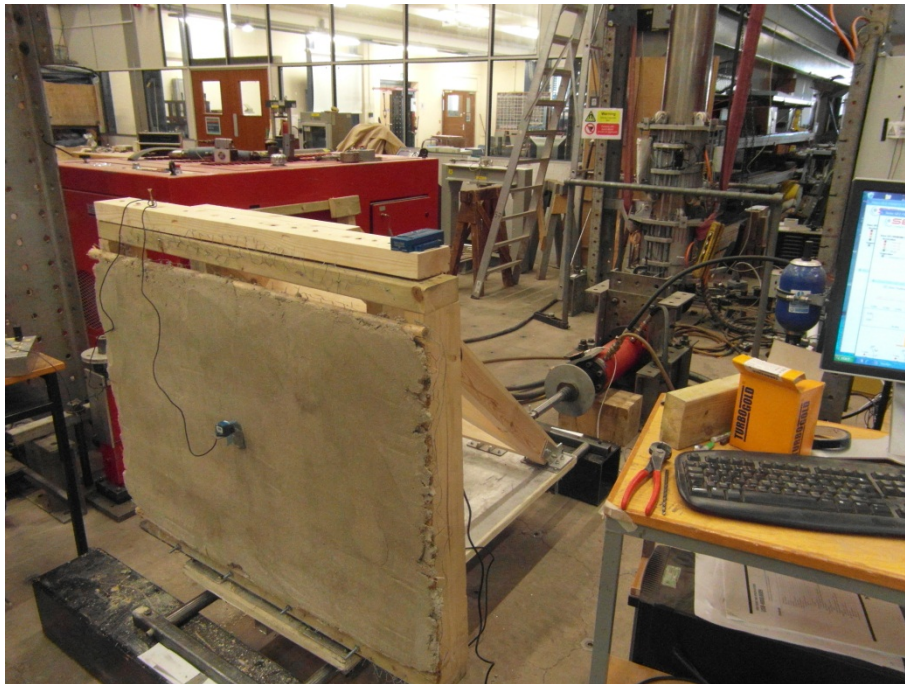
Figure 9. Out-of-plane testing of wall panels on a uni-directional shake-table at Cambridge University (Kaminski, 2015)

Out-of-plane, because the cane is placed horizontally, the only reliable load-path is using the cane flexurally. Testing of the cane flexurally at Coventry University indicated that it had a considerable strength, similar to bamboo, considerably exceeding the maximum out-of-plane loads assuming no composite action (Chan, 2014). Subsequent testing at Cambridge University on their small uni-directional shake-table was conducted in order to determine the panel failure mechanism and extent of spalling out-of-plane (Figure 9) (Davies, 2014). This is important as spalling can be dangerous to people and also reduces the capacity of the panel to resist in-plane loads.

Testing was conducted on panels with chicken mesh on one side and with chicken mesh on both sides. Static 3-point bending tests indicated that the mortar tensile capacity is more reliable than anticipated, and once the mortar has failed in tension the cane and the mortar on the compression side attempt to work compositely, until the bond between them breaks down and the cane resists the load flexurally by itself. The dynamic tests also indicated that the bond between the cane and the mortar was more reliable than expected, however that once the bond has failed the mortar may spall off quickly. This risk was shown to be reliably mitigated by introducing chicken mesh on both sides of the panel with steel wire through-ties connecting each face. This detail has now been adopted for the structural system.

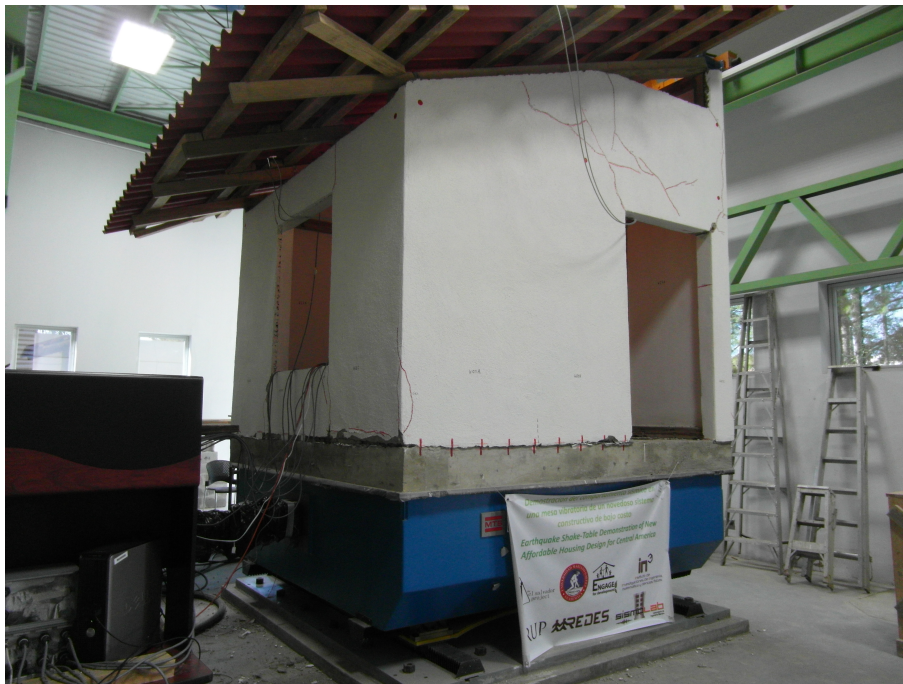
Figure 10. Damage state at end of bi-directional shake-table testing for a full-scale model of a room of a house at the Universidad Mariano Gálvez in Guatemala City (Kaminski, 2015)

A full-scale room of the house using the structural system was tested on a shake-table at the Universidad Mariano Gálvez in Guatemala City (Figure 10). The specimen consisted of four walls forming a 3m x 3m box on plan, 3m high and included one door and one window. Chicken mesh was placed on both sides of each wall panel. The house was tested bi-directionally by exposing it to two simultaneous time-histories of the 13th January 2001 El

Salvador earthquake (taken from the two orthogonal strong-motion components records from a single station with hypocentral distance 80km) (Centre for Engineering Strong Motion Data, 2015). The stronger of the two strong-motion records had a PGA of 0.86g, and the second 0.70g. Both time-histories were then scaled down to 10% of the original history and the house tested bi-directionally simultaneously. This test was then repeated but with the directions of the stronger and weaker records now swapped, hence allowing both axis of the house to be tested using the stronger of the strong-motion components. A thorough visual damage assessment was then conducted, and the testing repeated for the same time-histories but now each scaled to 15% of their original history. This testing cycle continued in 5% increasing increments, until 85% of the original history was reached.

The results were positive. Minor flexural cracking (<1mm) propagating from the corners of the lintels and doors occurred around and after the design event (0.5g). Bed joint sliding to one wall also occurred, however this joint is intended to slide and the ductile steel ties took the full load with little displacement. After this event, considering the load path and capacities of this particular structure, and assuming this damage level occurred throughout a whole real building (arguably conservative since a building would have a larger width-to-height aspect ratio), this damage could be considered “insignificant” to FEMA 306 (Applied Technology Council, 1998), with the building able to remain “Operational” to FEMA 356 (American Society of Civil Engineers, 2000).

Testing continued up to 85% of the original time-histories, with recorded PGAs >1.0g. The final three tests involved running three full cycles of the bi-directional time-history. At this point, the extent of flexural cracking had increased slightly (however all cracks were <1mm), and some minor spalling was visible from the corners of the doors and lintels. Bed joint sliding and some minor spalling of the mortar at the base also occurred. Upon inspection, it was found that on one wall 9 out of 12 of the steel straps had sheared under metal fatigue – this was considered to occur because these straps were inadvertently installed a little loose, so the wall had the ability to move and fatigue the straps. Despite this, the damage could be considered “moderate” to FEMA 306 because the vertical load carrying capacity remained

unaffected and the structure still had some horizontal capacity. Had this damage level occurred throughout a whole real building, it could be considered “Life Safe” to FEMA 356.
