NEWSLETTER

Volume 26 No 1
February 2015

Seismic Design of New Low- Cost Housing for El Salvador

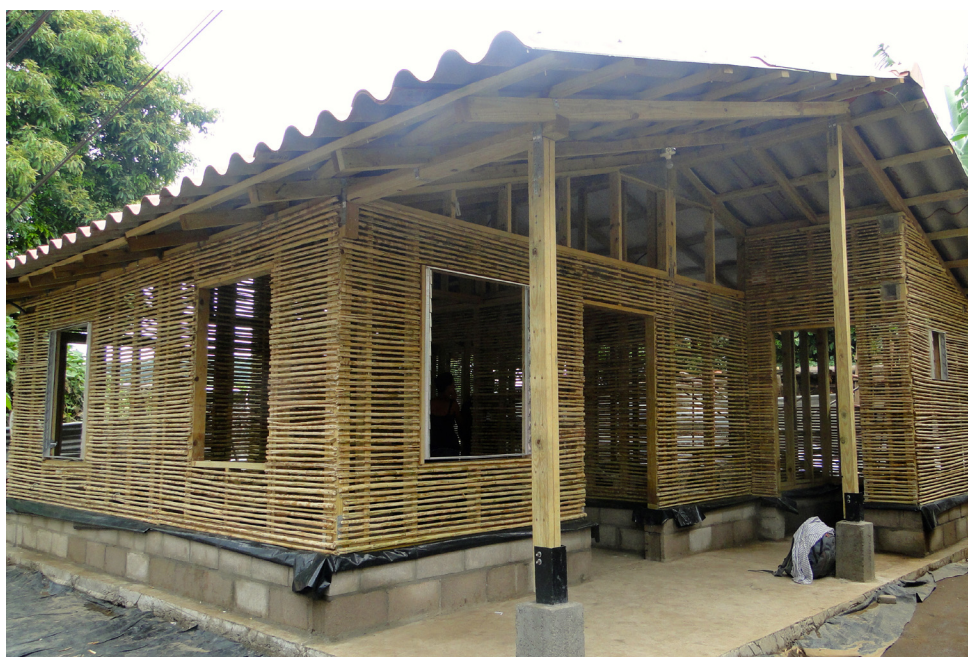
Figure 1: Prototype cane and mortar house under construction (El Salvador Project, 2012).

Two prototype houses were successfully built in El Salvador in 2012, and have allowed the house design and construction method to be optimised (El Salvador Project 2012, 2012). They were evaluated again in 2013 and the beneficiaries were very happy with them, with no reported structural problems (see Figures 1 and 2).

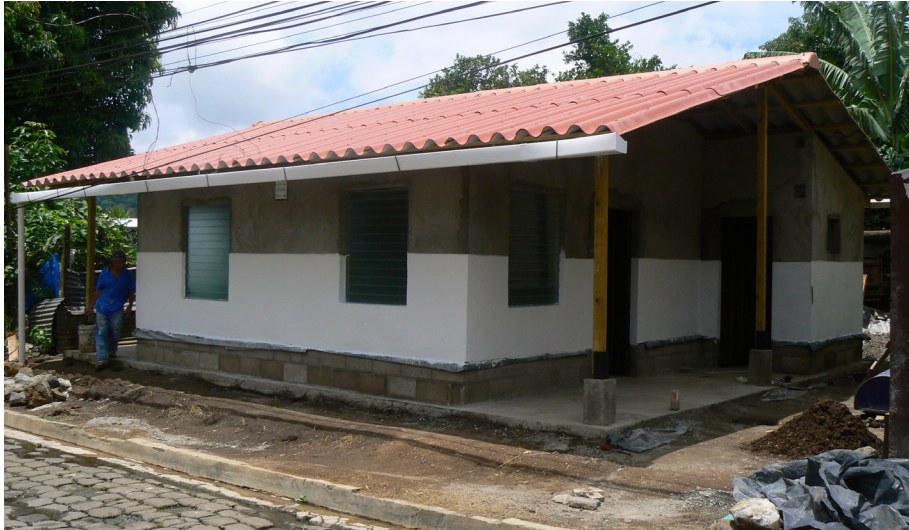
Figure 2: Prototype cane and mortar house, completed in 2012 (El Salvador Project, 2012).
© Sebastian Kaminski

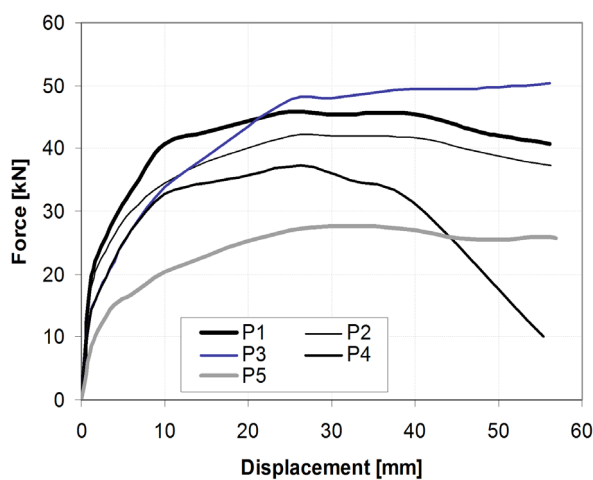
Figure 4: (a) Envelopes of the force-displacement hysteresis for different panel types, and (b) force-displacement hysteresis for one of the panels (Málaga-Chuquitaype et al, 2014).

The panels were each tested under cyclic displacement control based on the EN 12512 protocol (CEN, 2005). The results of the tests concluded that, for drifts under 1%, the level of damage was considered acceptable and the panels showed relatively stable hysteresis, with reasonably good levels of energy dissipation (Figures 4a and 4b). Initial cracking occurred at 15–20 kN (drifts of ~0.1%), with the ultimate load achieving 37–50 kN (drifts of ~1.5%). Initial failure manifested itself by a combination of diagonal shear cracking and spalling of the side of the panel without mortar (Figure 5). The steel mesh was found to stabilise the diagonal compression strut in the remaining mortar, and the ultimate failure mode was local buckling and crushing of this mortar.

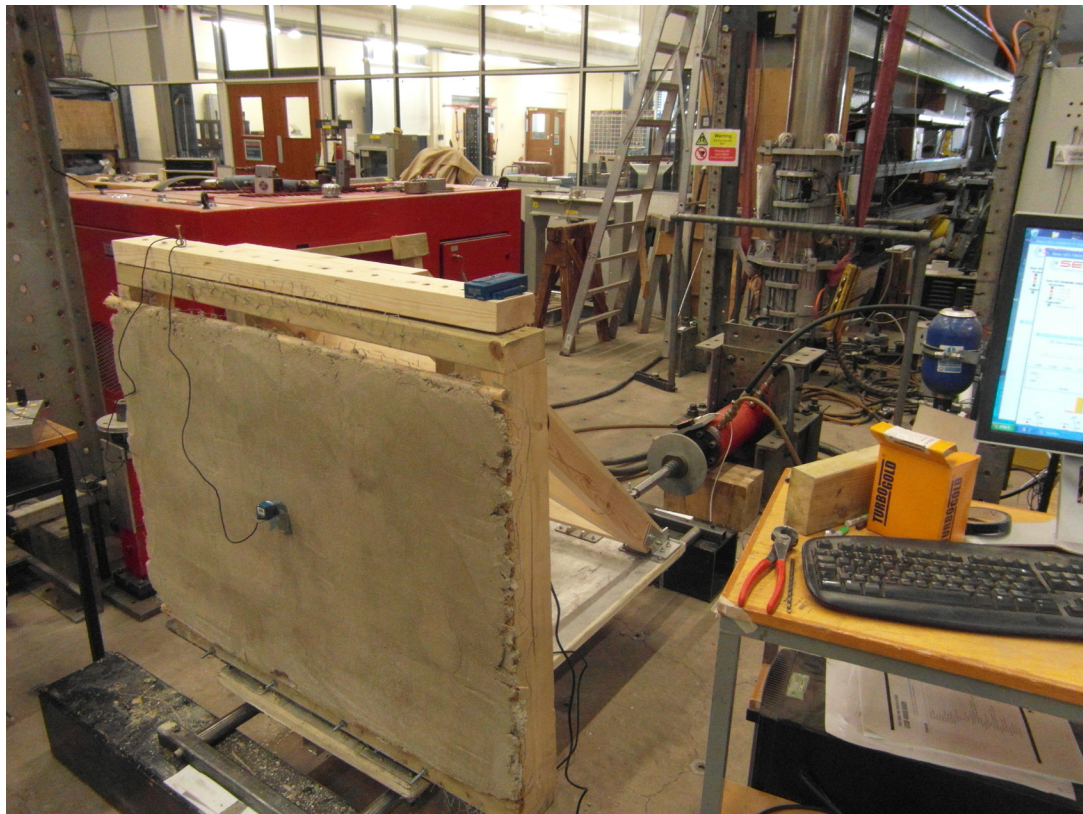
Figure 6: Set up for out-of-plane testing of wall panels on a uni-directional shake-table at Cambridge University (Kaminski, 2014).

For out-of-plane response, because the cane is placed horizontally, the only reliable load-path is using the cane flexurally. Testing at Cambridge University on their small uni-directional shake-table has been conducted in order to determine the failure mechanism and extent of spalling out-of-plane (Figure 6) (Davies, 2014). This is important as spalling can be dangerous to people and also reduces the capacity of the panel to resist in-plane loads. Static 3-point bending tests indicated that the mortar tensile capacity is more reliable than anticipated, and once the mortar has failed in tension the cane and the mortar on the compression side attempt to work compositely, until the bond

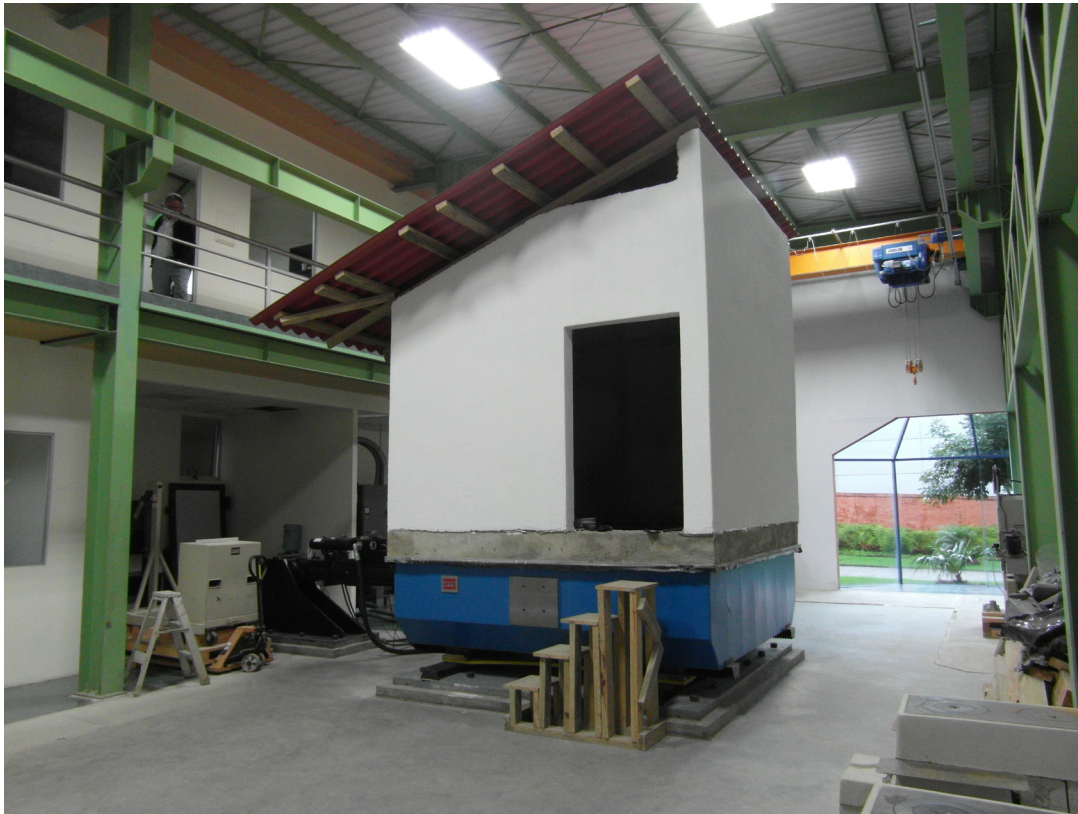
Figure 7: Completed full-scale room of a house at the *Universidad Mariano Gálvez* in Guatemala City, ready for bi-directional shake-table testing (Kaminski, 2014).

In early 2015 a bi-directional shake-table test of a room at full-scale built using the design will be conducted at the *Universidad Mariano Gálvez* in Guatemala City on their newly constructed 3 m × 3 m shake-table (Figure 7). The aims of the testing will be to provide evidence to potential donors that the house performs well in the design earthquake, as well as to verify the level of cracking in the frequent earthquake event.
