PERFORMANCE-BASED APPROACH FOR THE SEISMIC DIAGNOSIS OF HISTORIC BUILDINGS

Natalie QUINN¹, Carina FONSECA FERREIRA² and Dina D'AYALA³

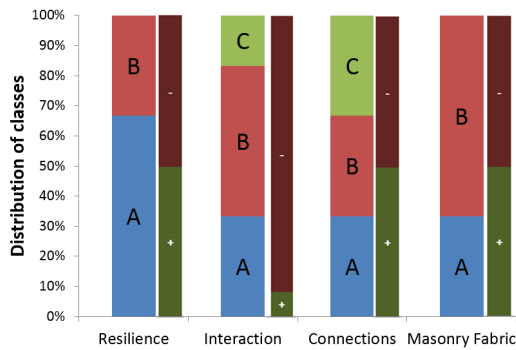
Figure 4. Distribution of influential classes and their nature per variable for C.A.

Results of Preliminary Diagnosis: Figure 4 summarises some of the results of the preliminary diagnosis of C.A., while Figure 5 shows the same results for K.T. The charts show the proportion of macroelements judged to have a particular influence (A, B, C or D), as well as the positive (in green) or negative (in red) nature of the influence for each variable.

The most influential variable for C.A. was considered to be resilience, while the most influential variable for K.T. was the interaction between the macroelements. In the case of resilience, both buildings were judged to have a positive resilience in around half of the cases. This is supported by the fact that both structures are composed of thick adobe walls with high base courses which protect the walls from raising water, which are indicators of good resilience. However, there are some vulnerable aspects such as the *par y nudillo* roof, and improper anchoring of tie beams to the walls that are present in both buildings. In the case of K.T., the interaction was considered unfavourable in all cases, and for C.A., the interaction was considered unfavourable more than 90% of the time. Interaction between walls (and walls/buttresses in the case of K.T.) is made by interlocking adobe blocks at orthogonal walls, with the roof having a negligible contribution to the redistribution of loads between the walls. In the case of K.T., the walls/buttresses connection could be limited to the adobe blocks located at outer layers and therefore the core of the buttresses might be detached from the walls as shown in Figure 6. Additionally, in both buildings, most of the tie-beams connecting the long longitudinal walls are not properly anchored to the walls, or are not present at all. Finally, in C.A., the floor beams do not run continuously (see Figure 7), and the lack of wall plates may lead to stress concentrations in the walls. Taking into account the significant influence and unfavourable nature of the interaction variable, the improvement of the way how the macroelements interact with each other is a major concern.

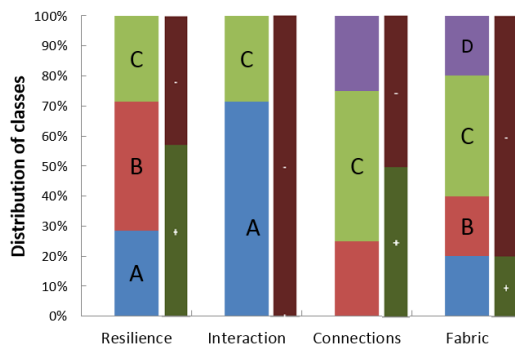
Figure 5 Distribution of influential classes and their nature per variable for K.T.

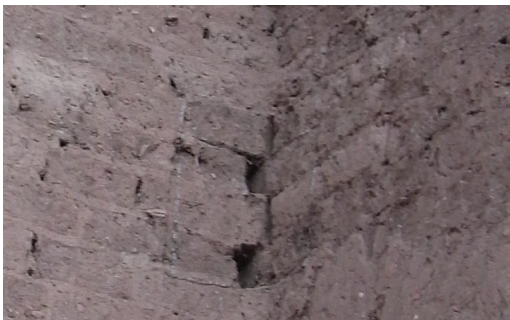
Figure 6. Connection of butters to lateral walls of K.T.

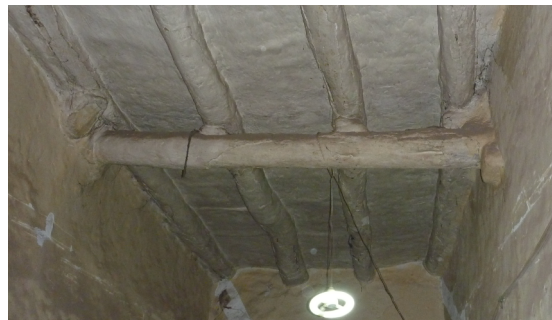
Figure 7. Interaction between floor beams and adobe walls for C.A.

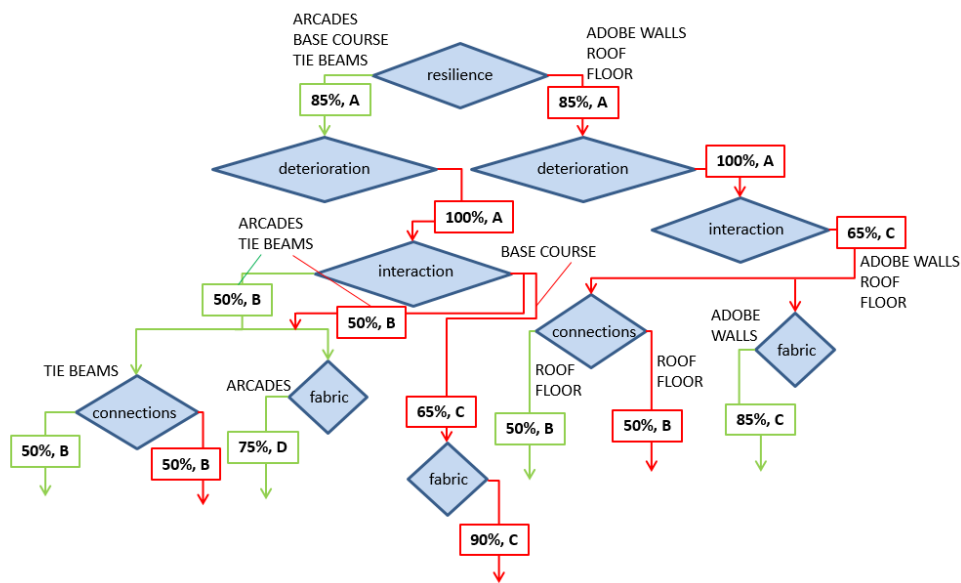
Figure 8. Performance-based diagnosis of CA (only the relevant paths are marked)

Results of Detailed Diagnosis: The detailed diagnosis of both buildings was carried out considering the results of the numerical models (Figures 1 & 2). Additionally, after the preliminary diagnosis, experimental tests were carried out by Vicente and Torrealva (2014) on original material extracted directly from K.T. It was not feasible to extract original material from C.A. so suitable values for the material characteristics had to be obtained from literature. Figure 8 shows the results of the detailed diagnosis of C.A. The results for C.A. do not differ extensively from the preliminary diagnosis. This is due, in part to the lack of experimental data available from material extracted from site. However, the numerical model showed the long unsupported adobe walls to be vulnerable to excessive drifts, and the interactions between orthogonal walls to be vulnerable to cracking (see Figure 9), which was observed on-site. A significant issue with the detailed diagnosis is also the lack of confidence on the positive or negative nature of the variables in relation to the lack of knowledge which would have been gained from having performed a good characterisation of the materials, either in situ or by extraction. This was compounded by difficulties in obtaining original connection details due to severe deterioration. In terms of resilience, the macroelements were divided and follow separate paths since half were judged to have a positive resilience, and half negative. Additionally, when interaction was considered for the arcades and tie-beams, there was not sufficient evidence to make a judgement so both paths were followed with a level of confidence of 50% each. This was also the case for the connections.

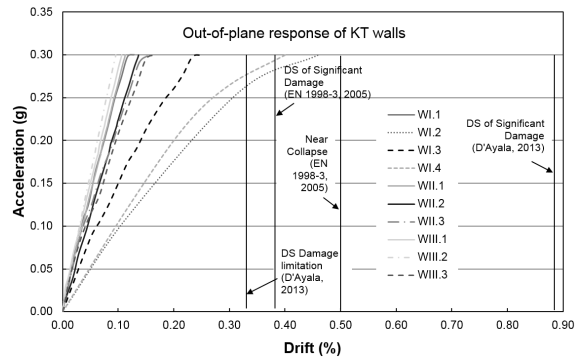
Figure 10: Maximum principal stresses after pushover analysis (equivalent acceleration of 0.3g) for K.T.

The capacity curves of K.T. presented in Figure 10, were developed from the results of pushover analysis performed with the model in Figure 2. These show that the longitudinal walls of the nave are the most vulnerable macroelements, which present a significant nonlinear plastic response from 0.20% drift, which corresponds to an acceleration of 0.2g (for details see Fonseca Ferreira *et al.*, 2014). These walls exceed the damage state of significant damage if for instance the reference drift range from FaMIVE for combined response of masonry walls (see Table 4, D'Ayala, 2013) is considered. The results of the numerical models also show that the buttresses are more beneficial to the overall response of the church than the tie-beams. Furthermore, if the buttresses of the West wall are reinstated, the wall might survive an acceleration of 0.3g without significant damage.

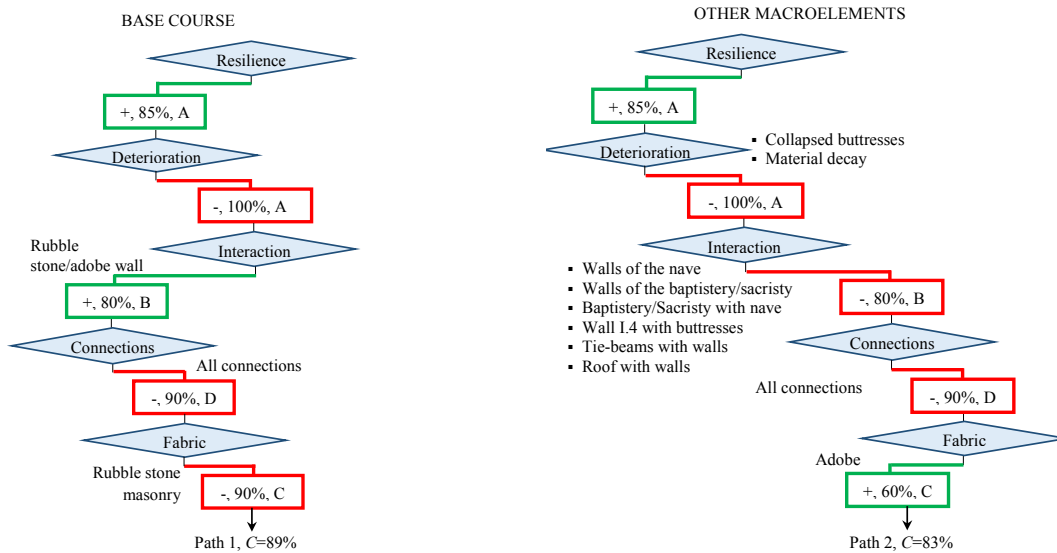
Figure 11. Performance-based diagnosis of KT

The overall diagnosis for K.T. is shown in Figure 11, where deterioration is considered as one of the most relevant variables due to the significant influence of the buttresses on the response, as interpreted from the results of the structural analysis. It can be seen that the decision-tree for K.T. is significantly less complex than that of C.A. This is due to the lower complexity of the building, and the higher level of confidence as a result of material testing.
